Composite Failure Analysis Handbook Update #1

Boeing Defense & Space Group

April 1995

Final Report for the Period Aug 90 - Apr 95

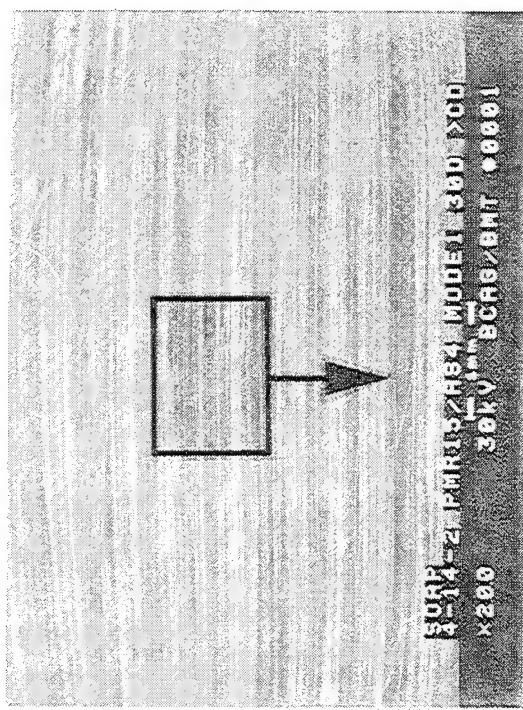
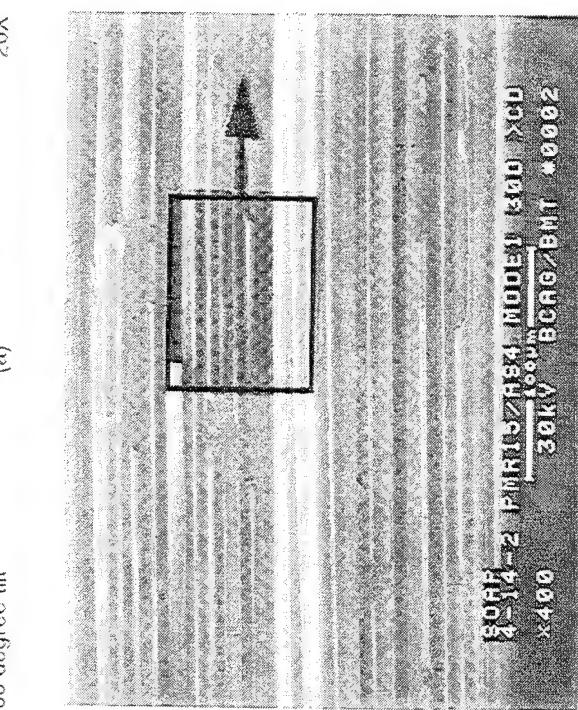
The effects of the exposure did not affect the fracture morphology to any noticeable degree. All of the characteristic mode I surface features were easily identified (Figure 3.3-9 through 3.3-15).

Figure 3.3-14. SEM Fractographs of a PM11-15/AS4 Interlaminar Mode I Tension Fracture Surface Exposed to Soap Solution for 24 hours

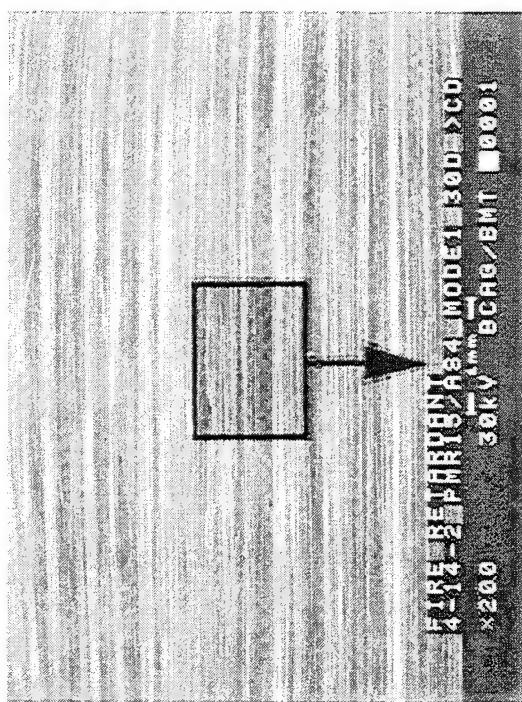
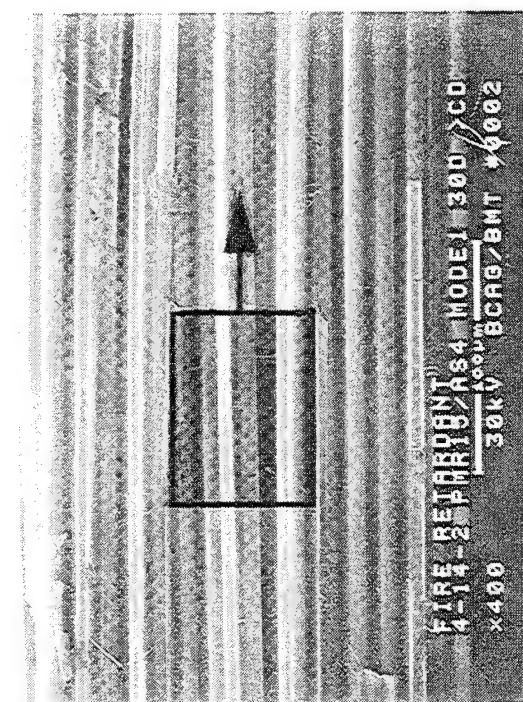
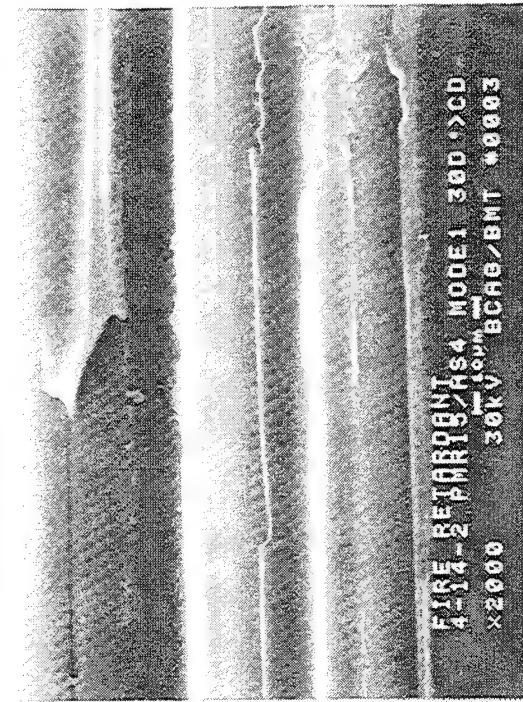
Figure 3-3-15 SEM Fractographs of a PMR-15/ASA Interlaminar Mode I Tension Fracture Surface Exposed to Fire Retardant Foam for 7 Days

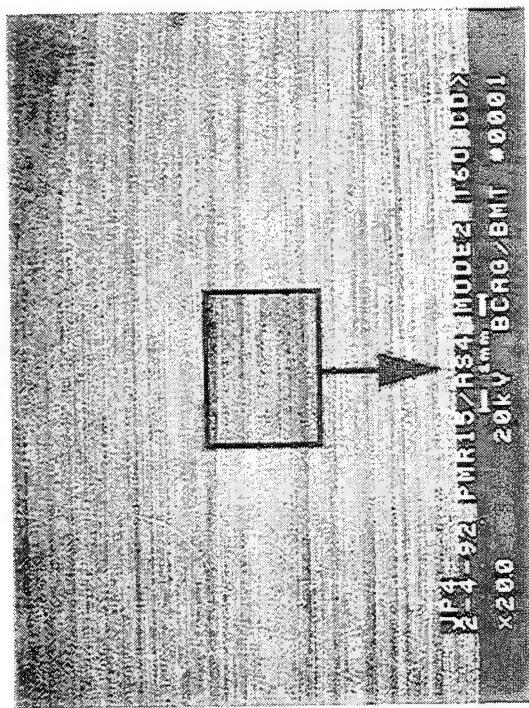
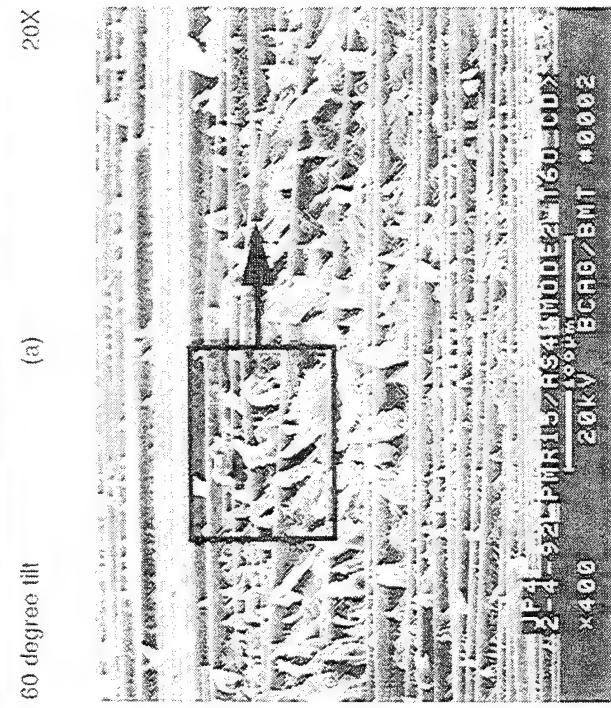
Of all of the environments (Figures 3.3-16 through 3.3-22), only the exposure to the fire retardant (Figure 3.3-16) and the hydraulic fluid (Figure 3.3-19) slightly degraded the resin microflow features observed on the mode II surface. Even though these features were degraded, the surface was readily identified as a result of a mode II fracture.

Figure 3.3-16. SEM Fractographs of a PM11-15/ASA4 Interlaminar Mode II Shear Fracture Surface Exposed to JP4 Jet Fuel for 7 Days

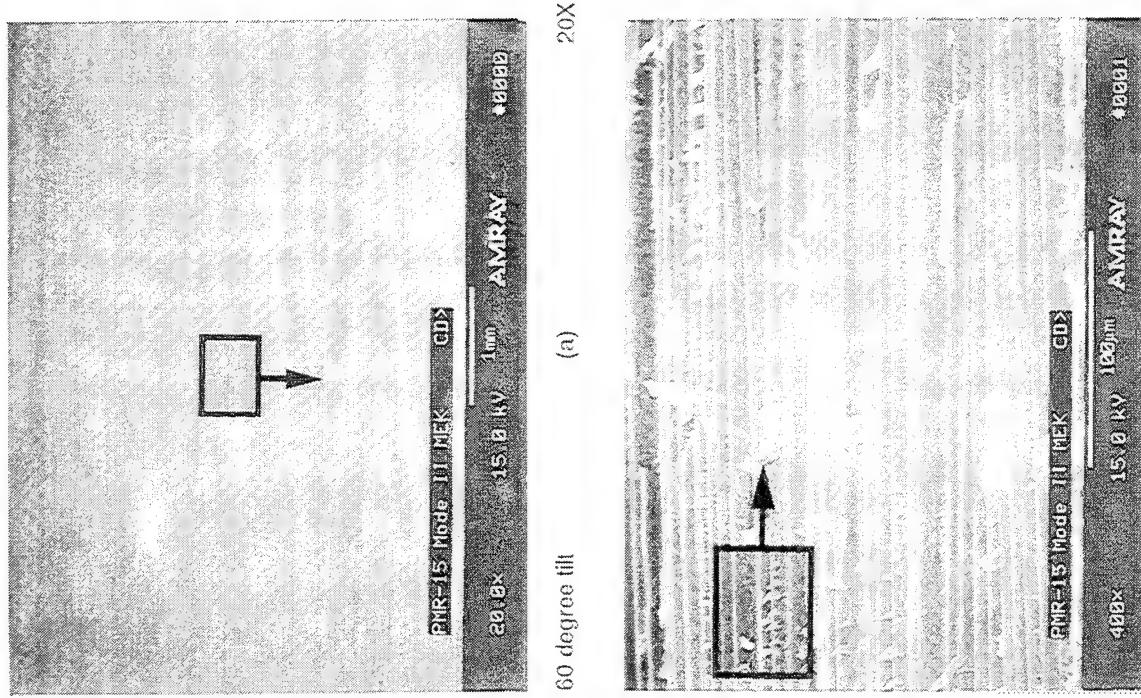
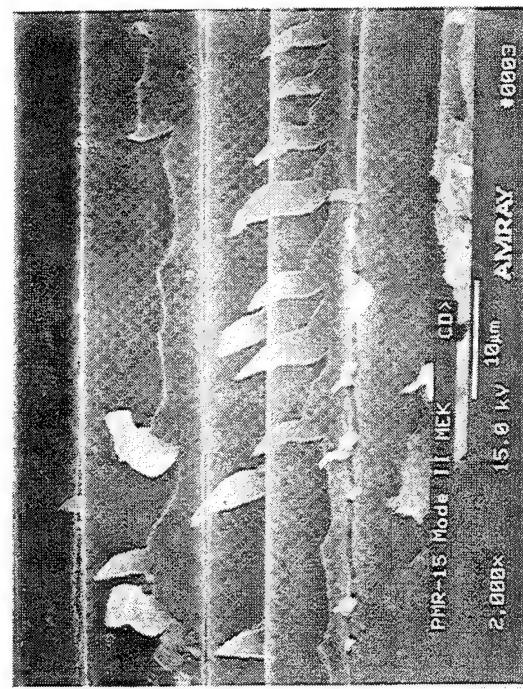
Figure 3.3-18. SEM Fractographs of a PMR-15/AS4 Interlaminar Mode II Shear Fracture Surface Exposed to MEK for 24 hours

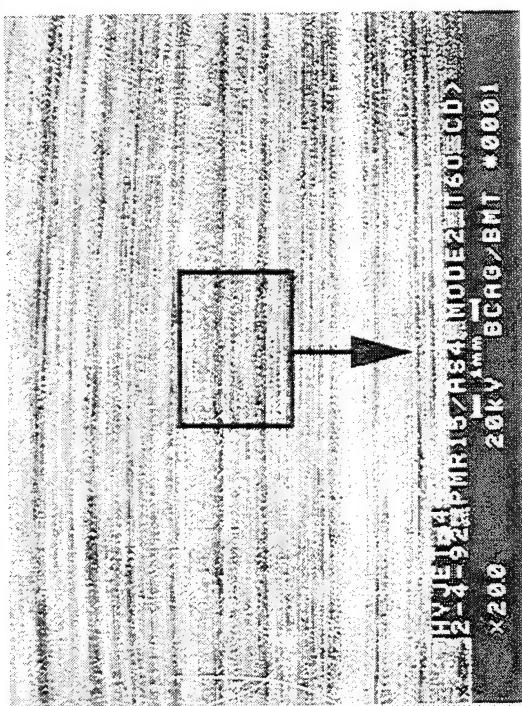
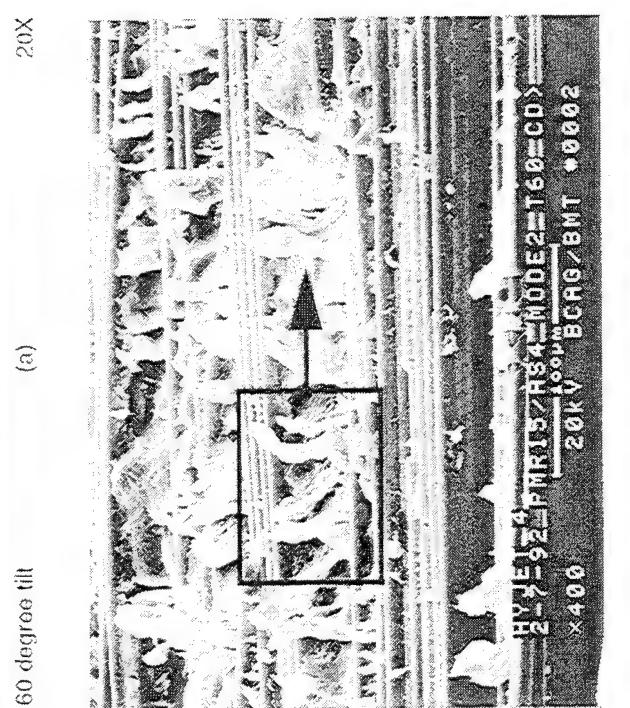
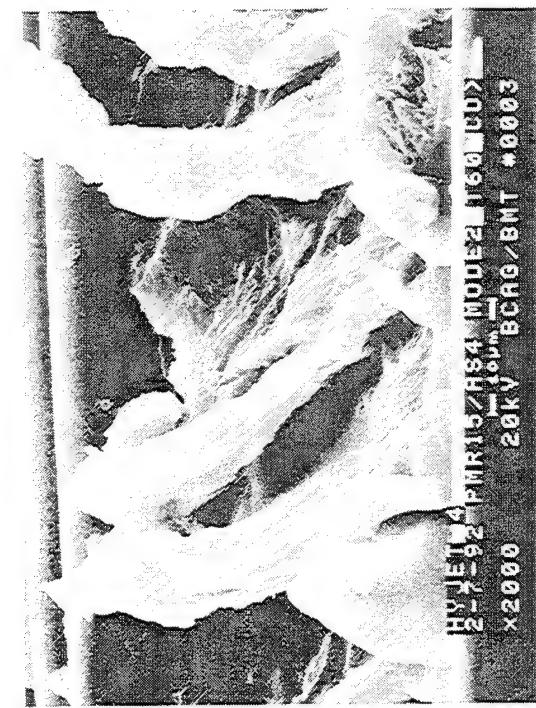
Figure 3.3-19. SEM fractographs of a PMMA-15/AS4 interlaminar shear fracture surface exposed to hydraulic fluid for 7 days
2357.02 L7220 D8 airR1

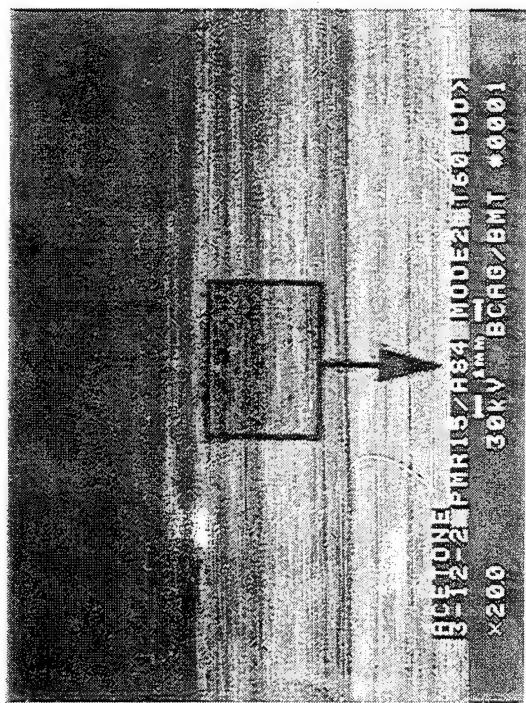
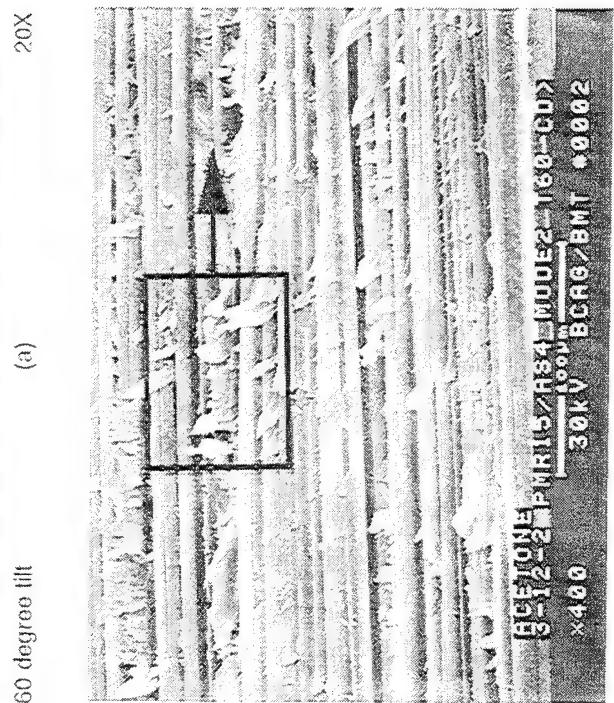
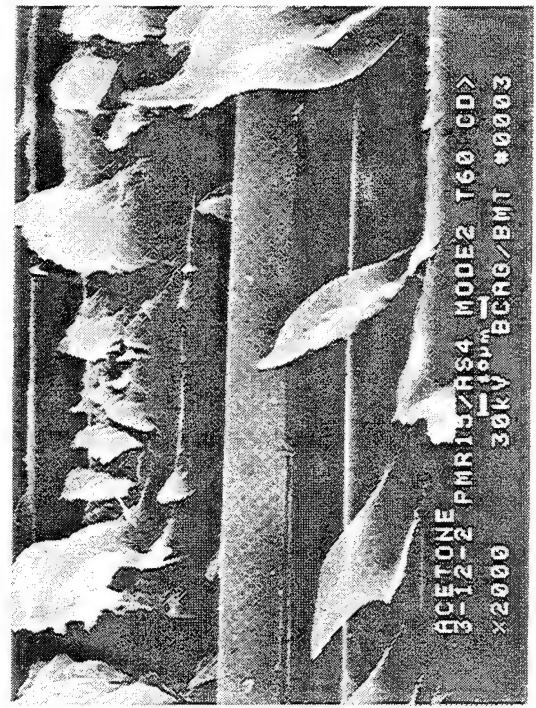
Figure 3.3-20. SEM Fractographs of a PMR-15/AS4 Interlaminar Mode II Shear Fracture Surface Exposed to Acetone for 24 hours
2357.03 1.7220 D8 air1

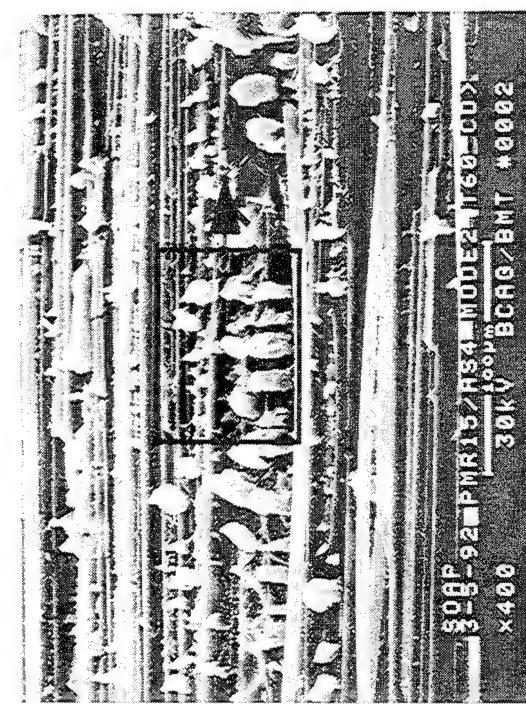
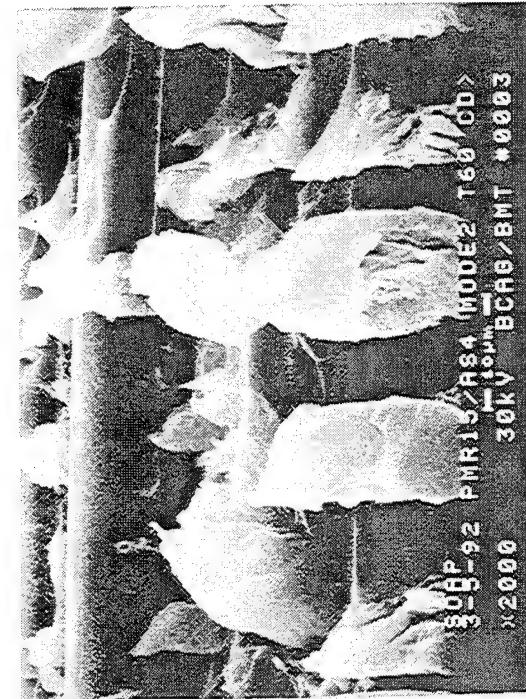
Figure 3.3-21. SEM Fractographs of a PMR-15/AS4 Interlaminar Mode II Shear Fracture Surface Exposed to Soap Solution for 24 hours

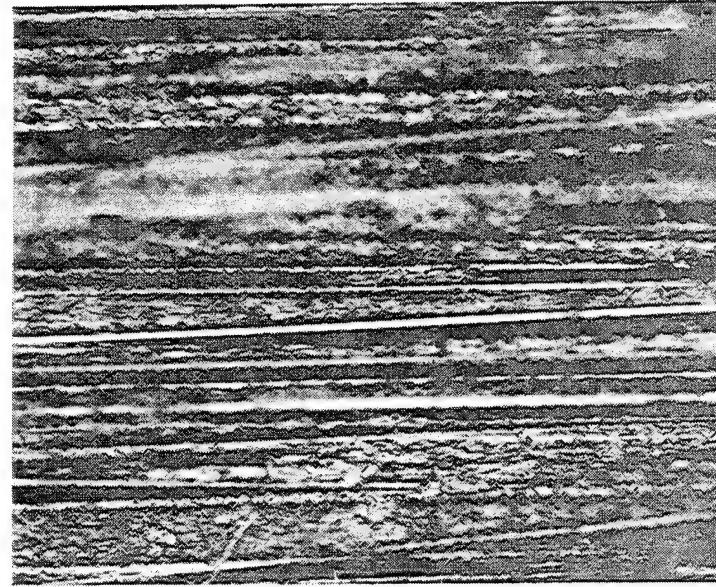
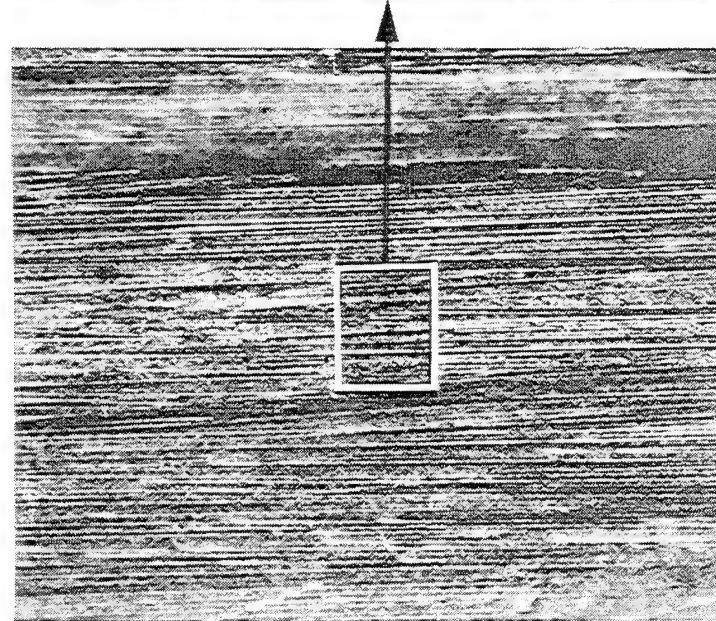
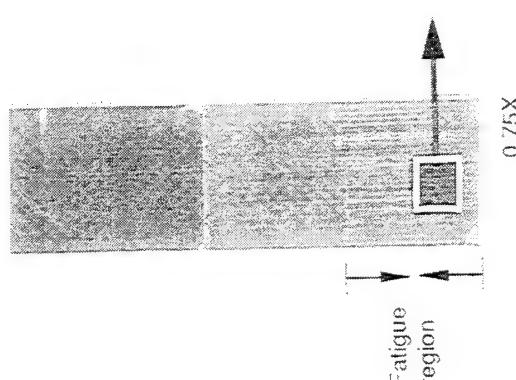
As shown in Figures 3.4-1 and 3.4-2, the fracture surface morphology of the RT specimen appeared typical for the mode II (shear) Gr/PEEK fracture surface. However, the hackle feature on this surface was considerably smaller than the statically loaded specimen and was probably unique to the cyclic loading.

Figure 3.4-1. Optical fractographs of PEEK/ASA interlaminar Mode II (Shear) Fatigue, Room Temperature, High Stress
49754.09 9-5571 D8 th

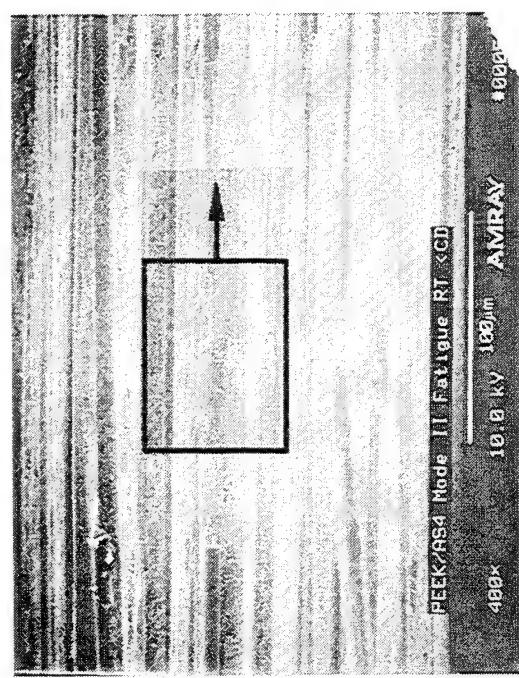
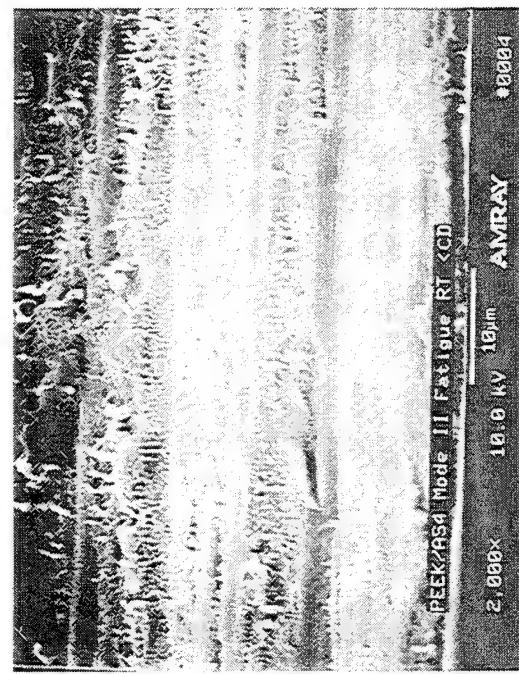
Figure 3.4-2. SEM fractographs of a PEKK/AS4 Interlaminar Mode II (Shear) Fatigue Fracture Surface, room temperature

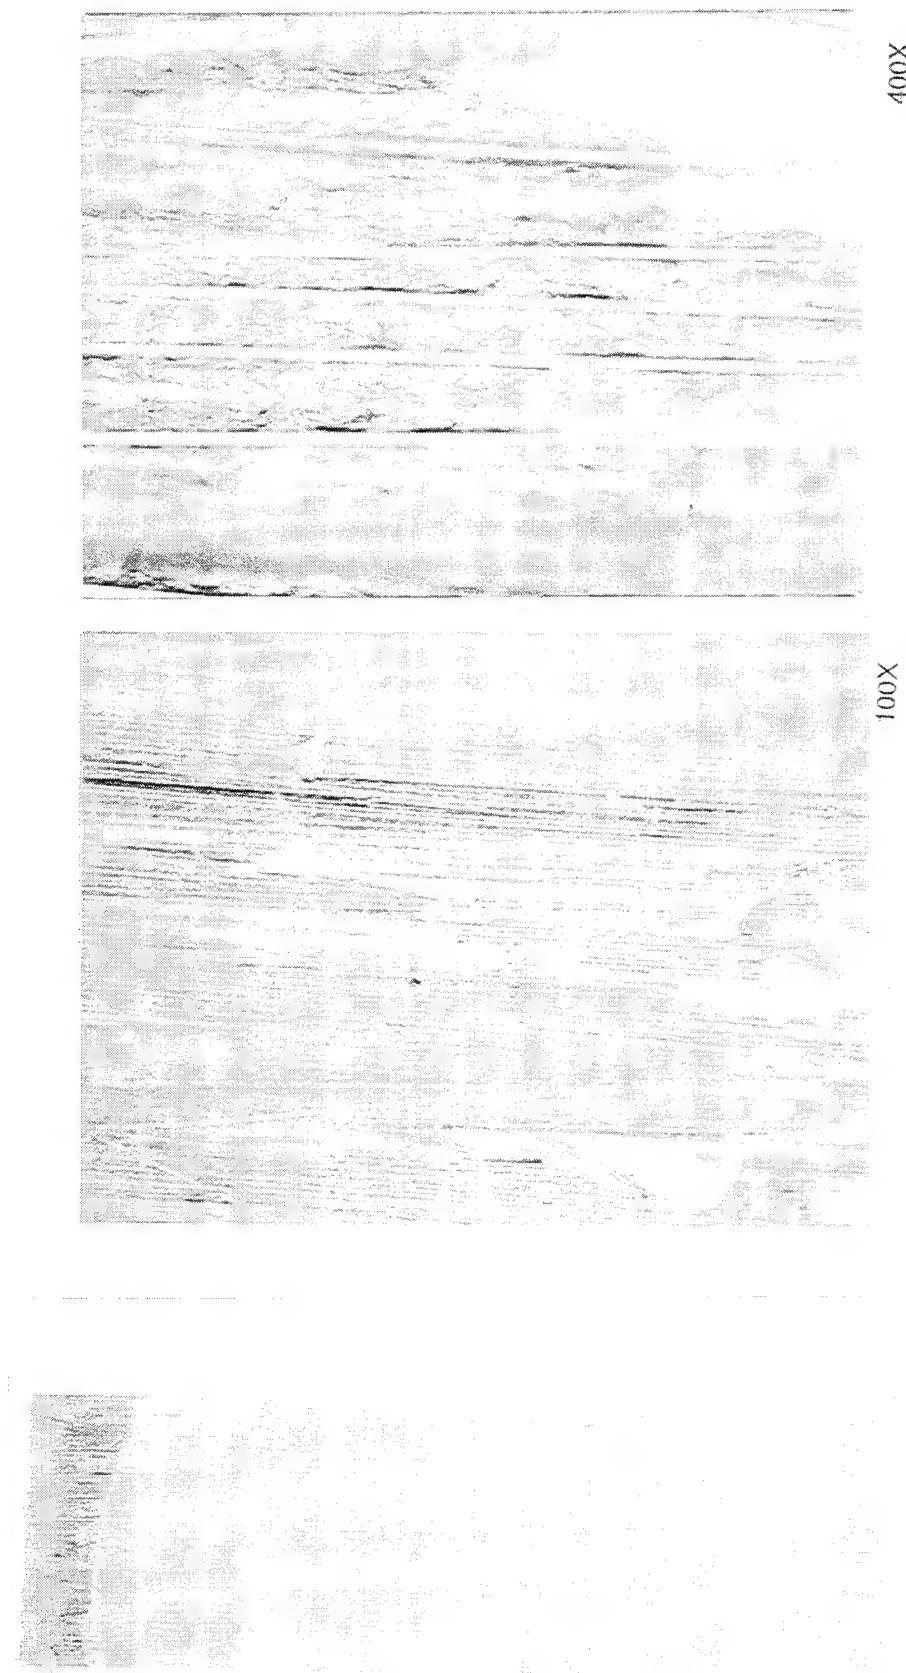
The fracture morphology was very different on the specimen tested at 250°F (Figures 3.4-3 and 3.4-4). The resin was pulled out in "ribbons" which did not indicate the overall crack propagation direction.

Figure 3.4-3. Optical fractographs of a APC-2/ASA Interlaminar Mode II (Shear) Fatigue Fracture Surface, 250° F

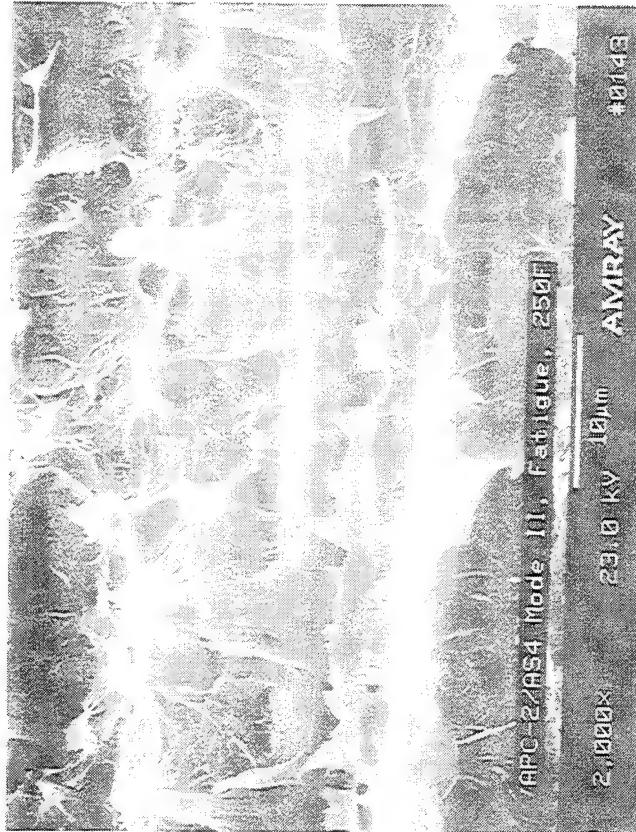
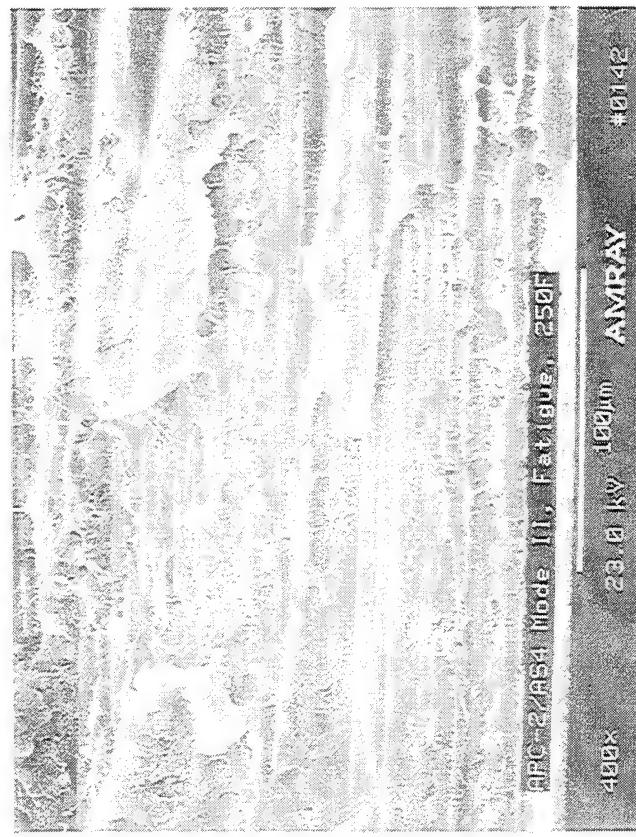
Figure 3.4.4. SEM Fractographs of a APC-2/AS4 Interlaminar Mode II (Shear) Fatigue Fracture Surface, 250° F

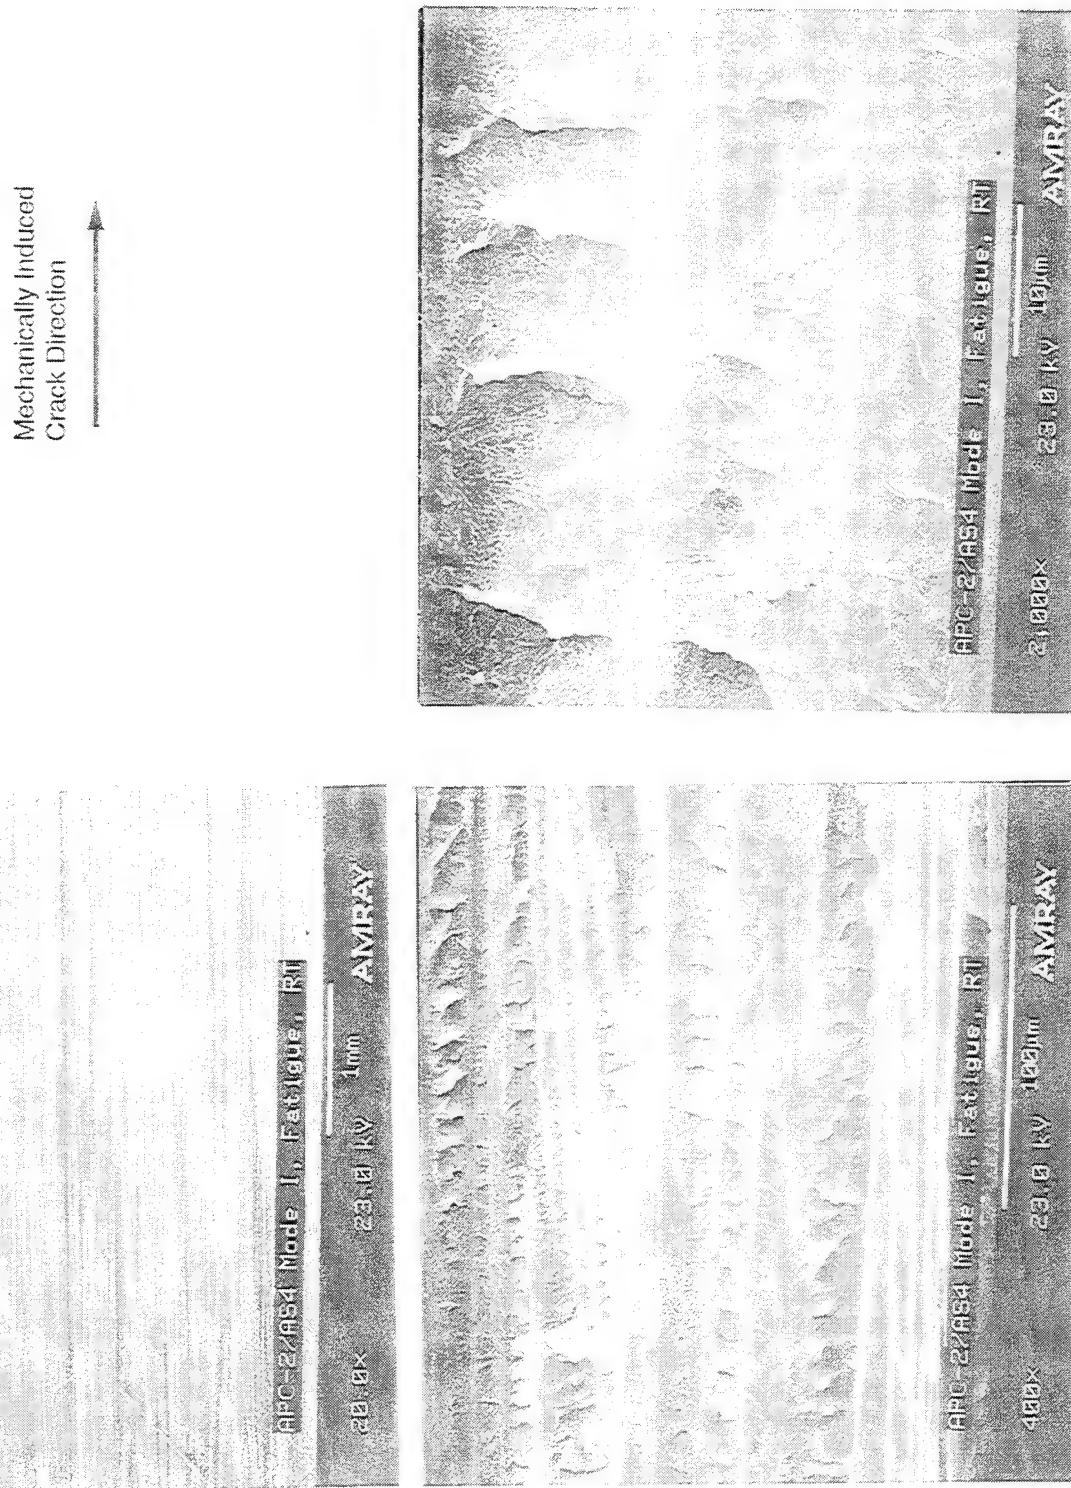
The RT fracture surface (Figures 3.4-5 and 3.4-6) exhibited features similar to large hackles between the fibers, oriented in the direction of the overall crack propagation direction. The plastic craze was also present throughout the entire surface including the large hackles.

Figure 3.4-6. SEM Fractographs of a APC-2/AS4 Interlaminar Mode I (Tensile) Fatigue Fracture Surface, RT

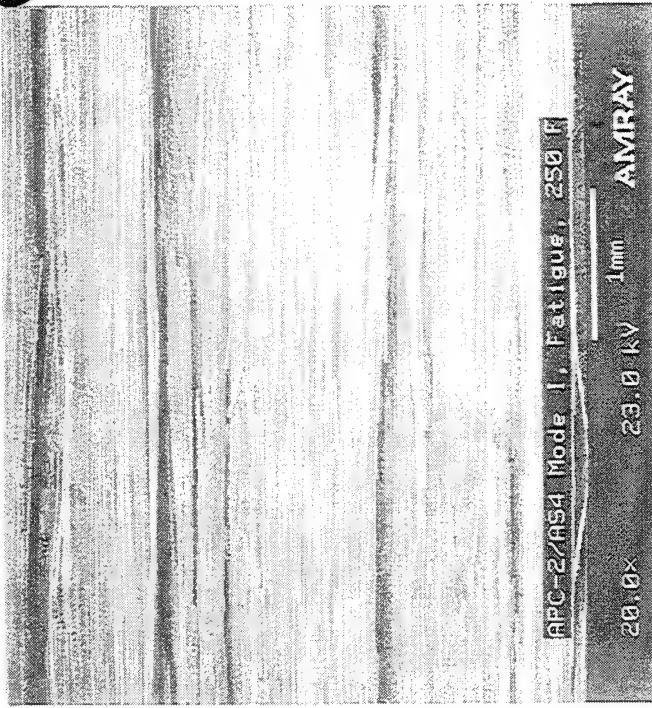
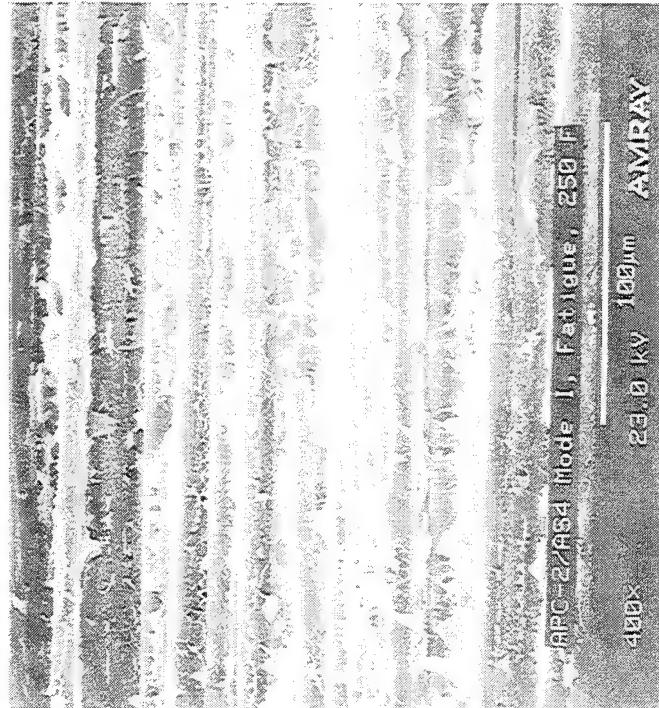
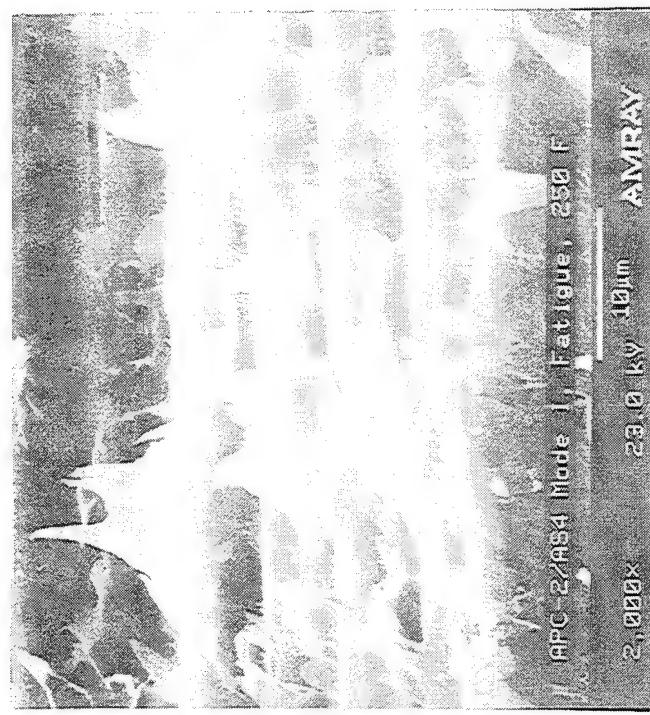
The morphology of the 250°F fracture surface (Figures 3.4-7 and 3.4-8) was different from the RT specimen. It consisted of the "ribbons" of resin that appear to have been pulled out from the surface. This was observed on the mode II (shear) fatigue fracture surface. These "ribbons" did not give any indication to the overall crack propagation direction.

Figure 3.4-8. SEM Fractographs of a APC-2/AS4 Intertanin Mode I (Tensile) Fatigue Fracture Surface, 250°F

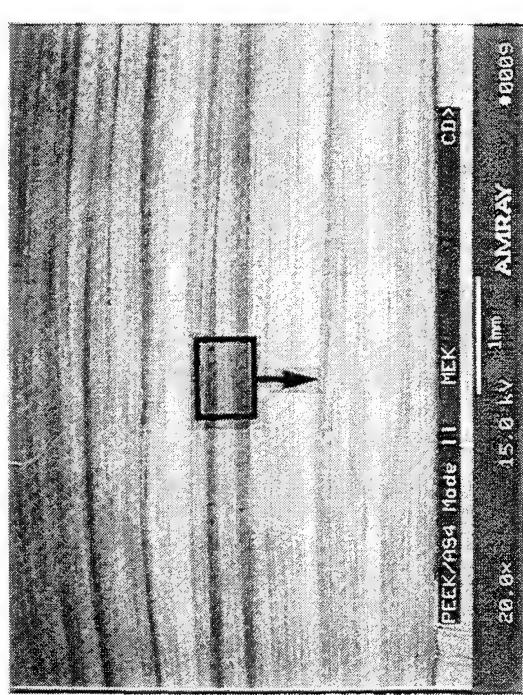
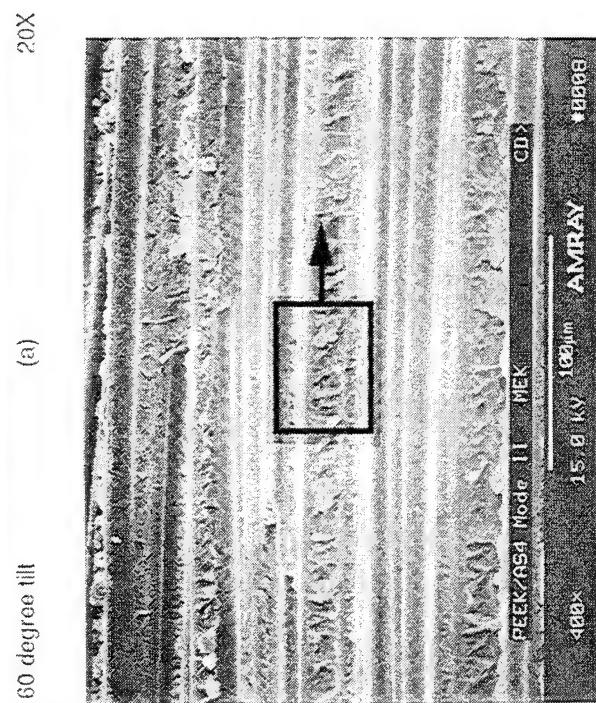
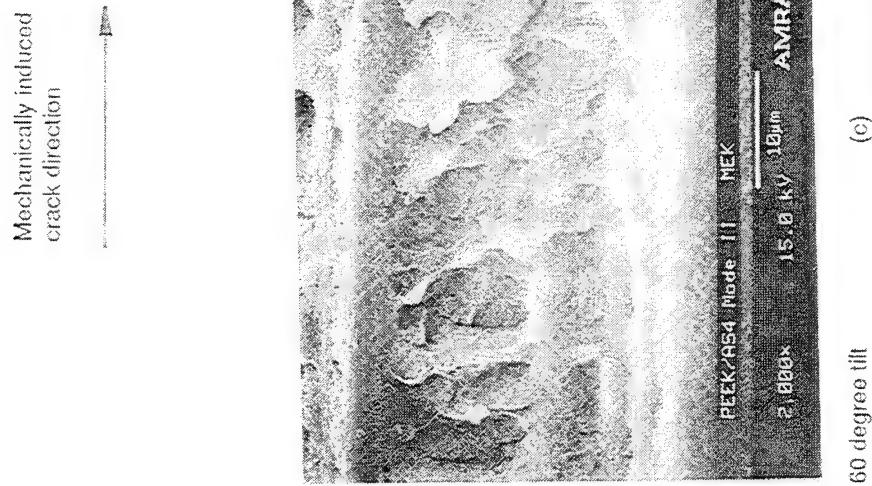
Examination of the fracture surface revealed the characteristic surface features for both the mode I (tension) (Figure 3.4-9) and mode II (shear) (Figure 3.4-10), respectively. There appeared to be no degradation in the surface feature due to the exposures.

Figure 3.4-10. SEM Fractographs of a PEEK/ASA4 Interlaminar Mode II Shear Fracture Surface Exposed to MEK for 24 Hours
49829.03 9-5576 Detail

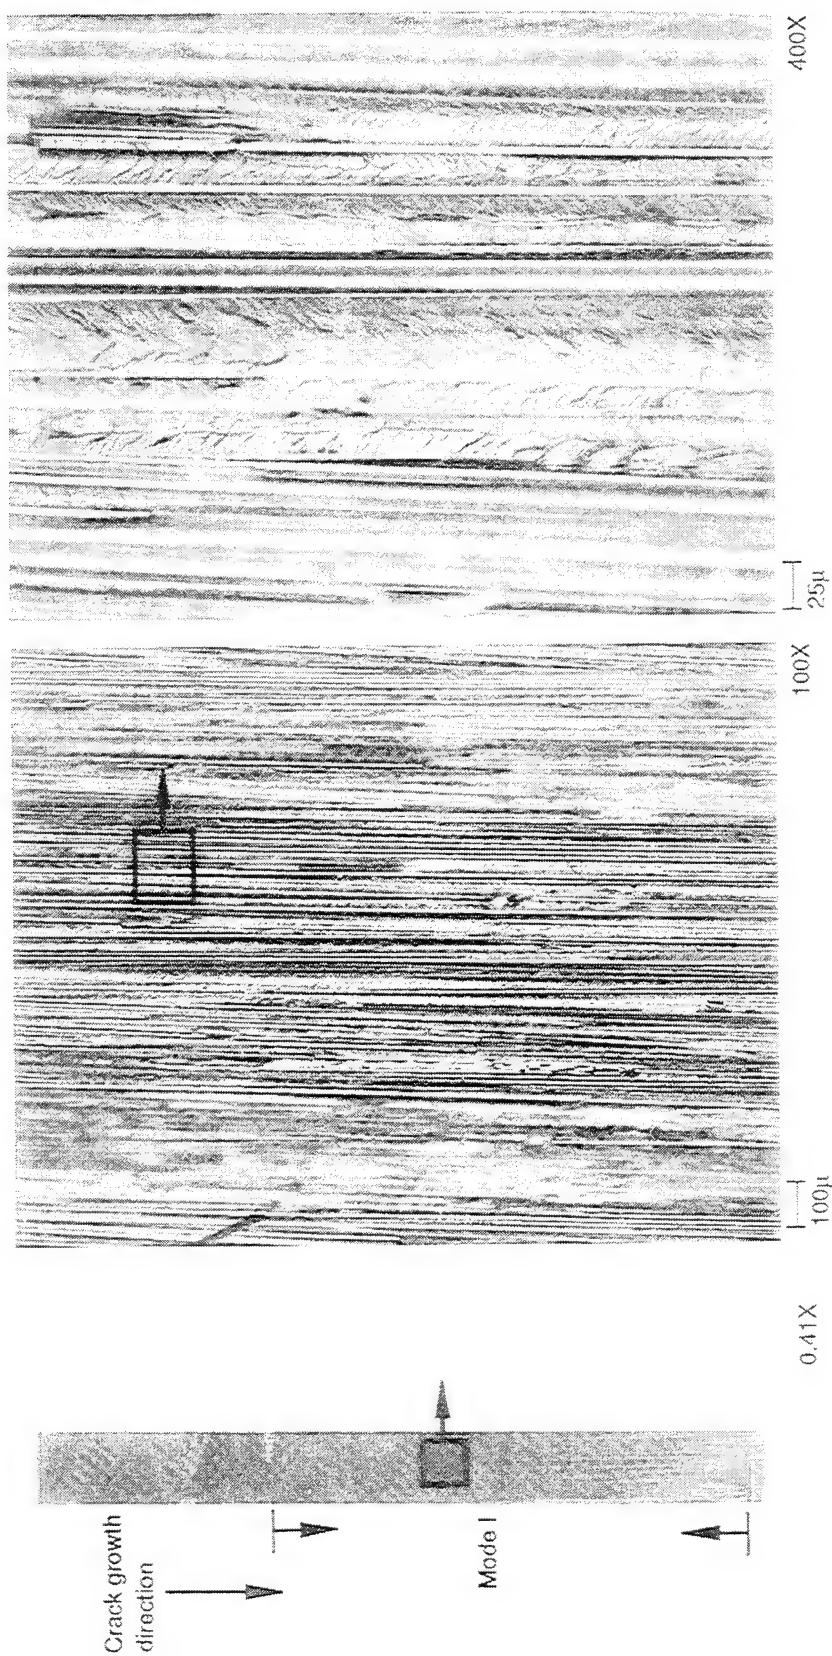
Visual observation revealed a smooth, glassy surface typical of an interlaminar mode I tension fracture. However, fragments of loose fibers were apparent on the fracture surface. These fibers were separated from the matrix (possibly due to weak fiber/matrix adhesion). Under the optical microscope, fine rivermarks were observed, indicating the overall crack propagation direction (Figure 3.5-1). As shown in Figure 3.5-2, SEM examination revealed rivermarks between the carbon fibers. These rivermarks indicated the crack growth is consistent with the mechanically induced crack direction.

Figure 3.5-1. Optical Fractographs of B3M/AS4 Interlaminar Mode I Tension Specimen Tested at 117/Dry

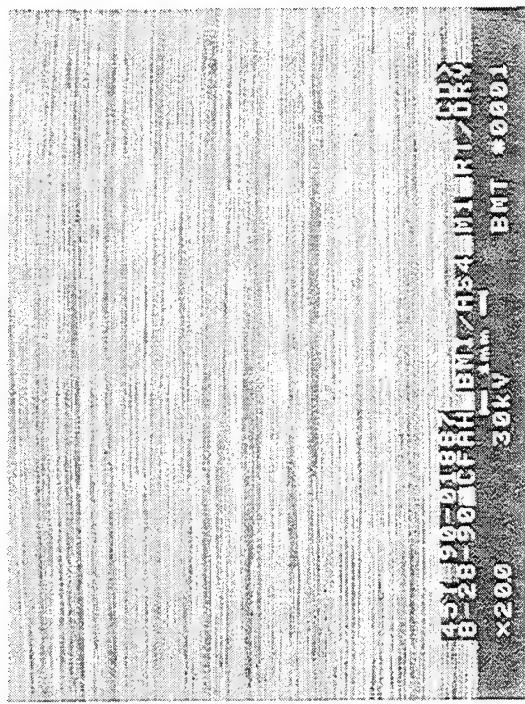
Figure 3.5-2. SEM Fractographs of an AS4/3M1 Interlaminar Mode I Tension Specimen Tested at RT/dry

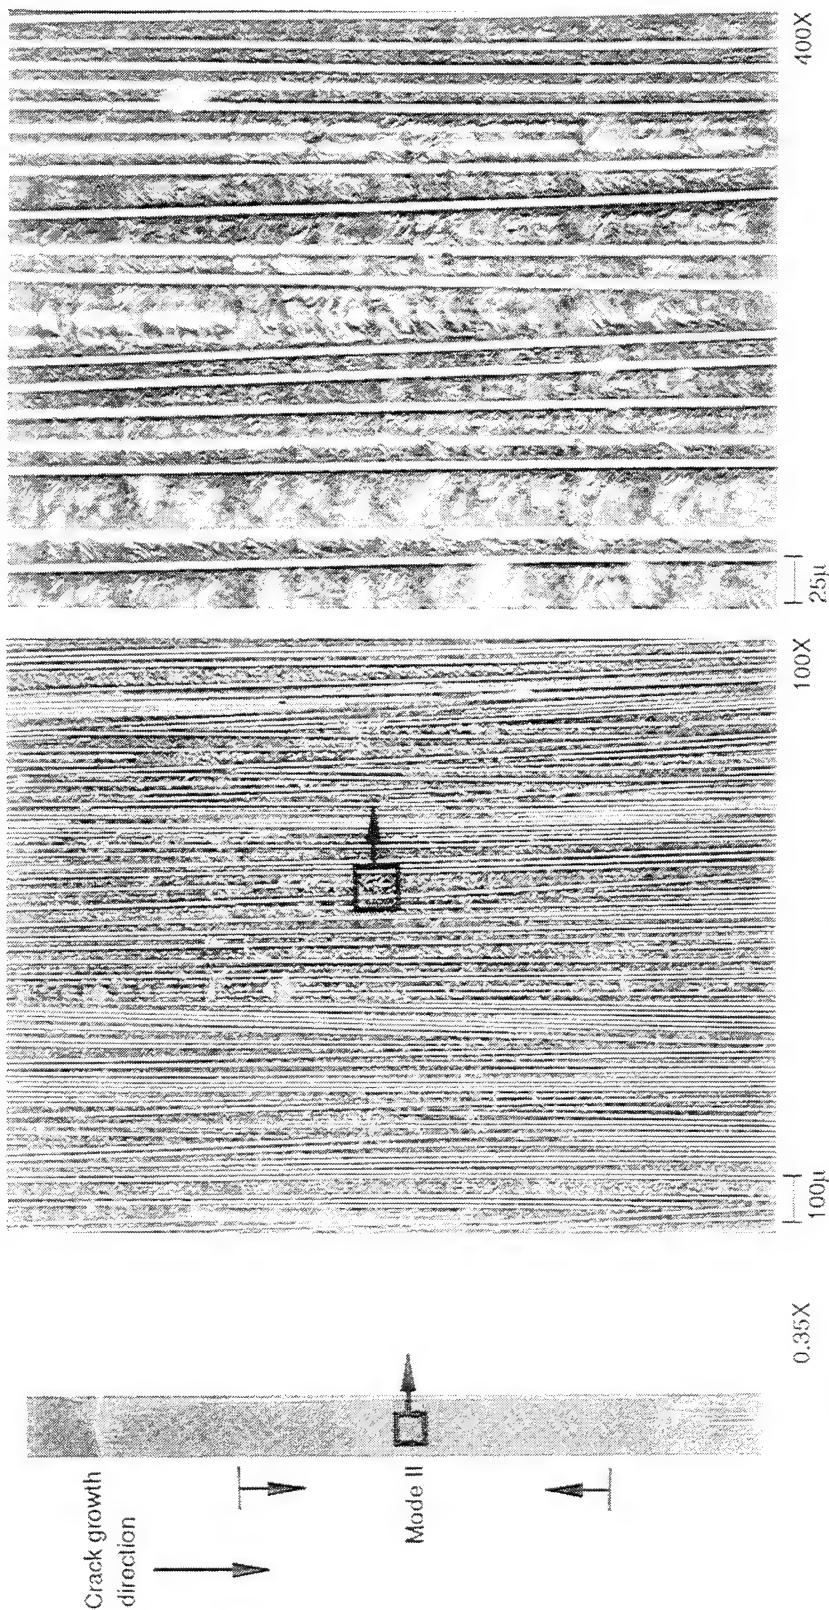
Figure 3.5.3. Optical Fractographs of BMM/AST interlaminar Mode II Shear Specimen Tested at RT/Dry

Visual observation of the fracture surface revealed a flat but milky appearance when held at an angle to the light. The milky appearance is due to the hackle formation created by shear loading, which was observed at higher magnification under the optical microscope (Figure 3.5-3). SEM examination revealed hackles of different sizes, shapes, and tilt angles located between the carbon fibers (Figure 3.5-4).

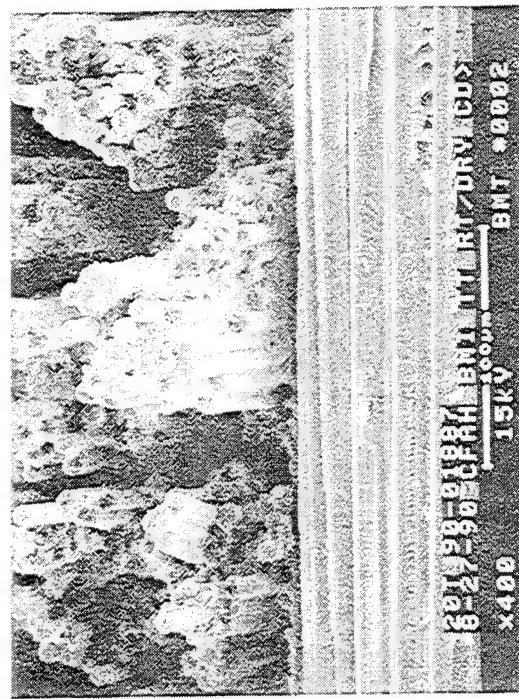
Figure 3.5-5. SEM Fractographs of an AS4/BMI Translaminar Tension R770y Fracture

SEM fractography (Figure 3.5-5) revealed radial patterns on the fiber ends, indicating a resultant crack direction consistent with the mechanically induced direction. The specimen tested at 450° F did not fracture but only bent during the testing (Figure 3.5-6)

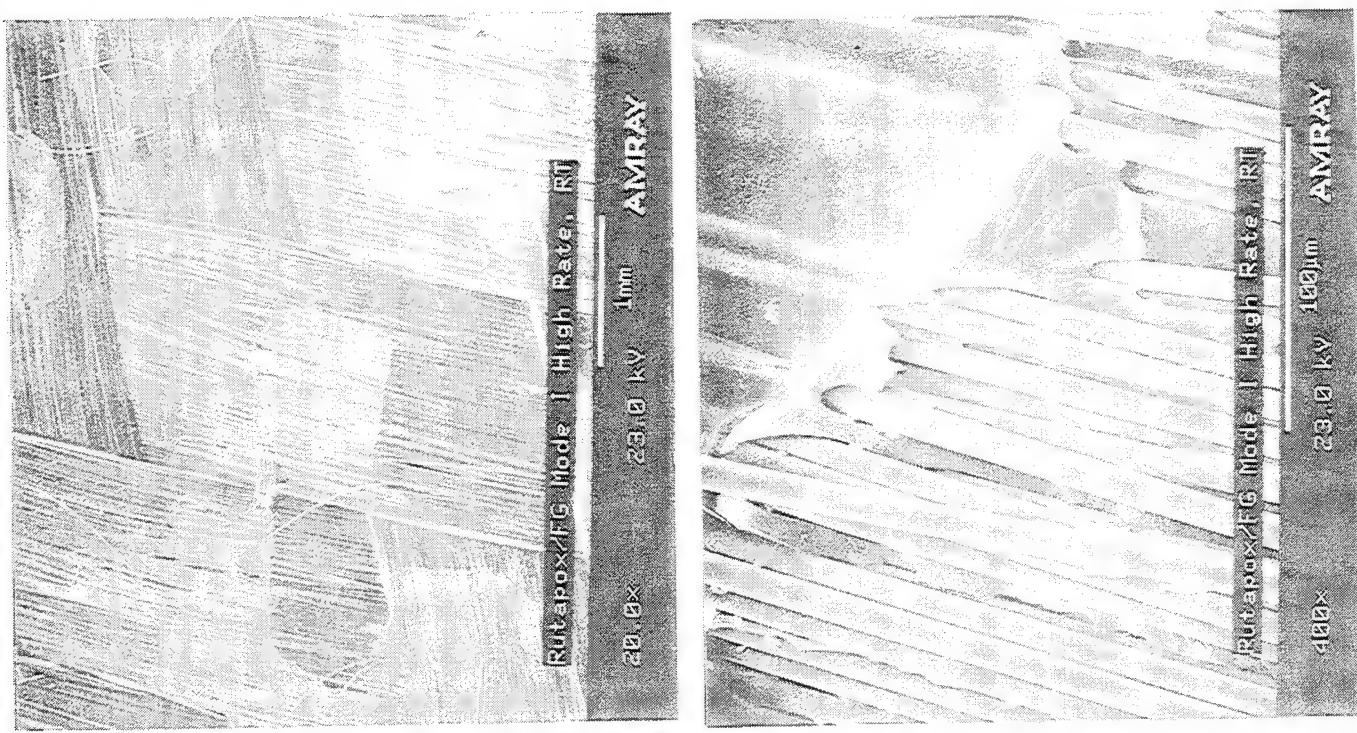
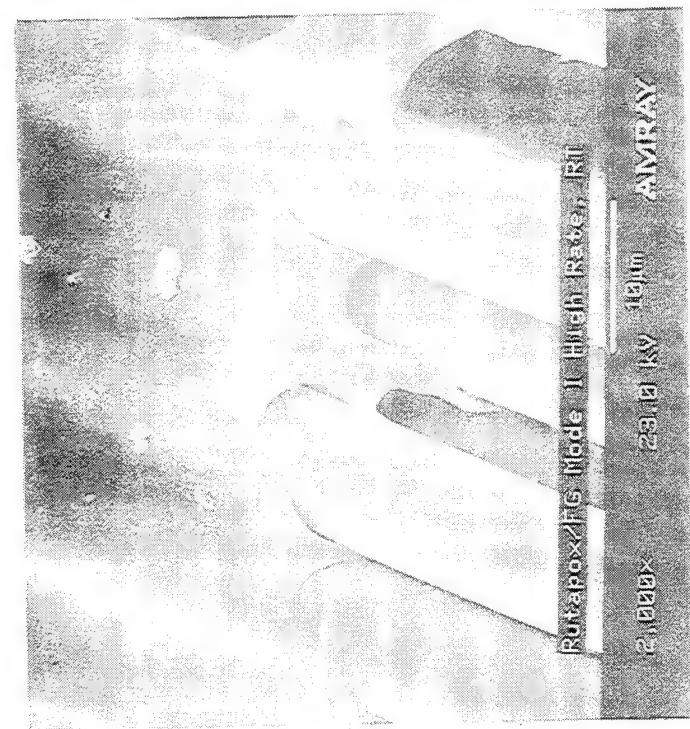
Figure 3.6.4. SEM Fractographs of a Rutapox/FG Fabric Interlaminar Mode I (Tensile) High Rate Fracture Surface, RT

The fracture surfaces of both specimens exhibited similar features (Figure 3.6-4 & 3.6-5). The fabric tows parallel to the crack propagation orientation contained the hackles typical of a shear loading. Whereas the tows perpendicular to the crack direction exhibited ribbons of resin tearing from the fibers. The torn ends were generally bent towards the crack propagation direction.
